PANEL SEPARATION OF GCLs UNDER AN EXPOSED MEMBRANE

GRI White Paper #5

In-Situ Separation of GCL Panels Beneath Exposed Geomembranes

April 15, 2005

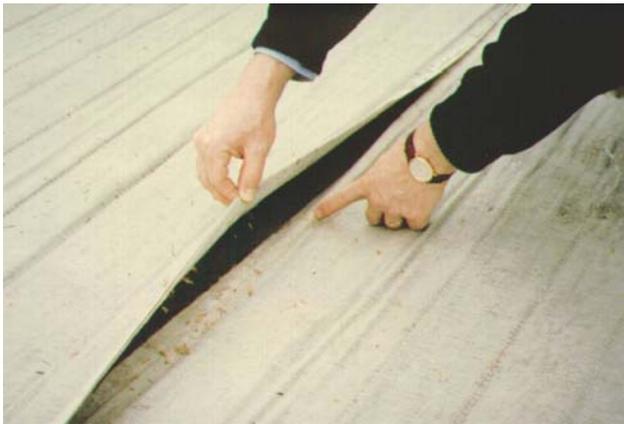
(a) Loss of initial overlap - no separation, hence, not included in Table 1

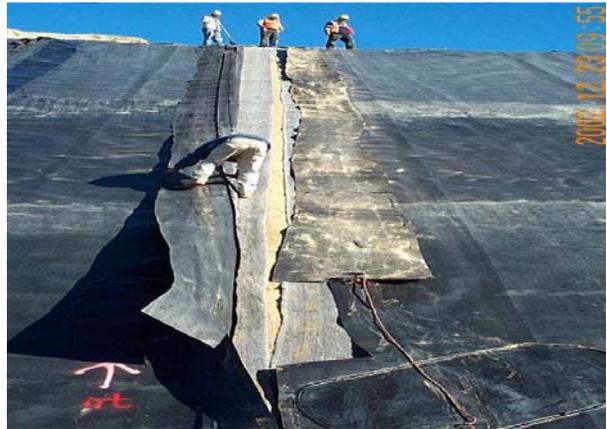
(b) Separation of GCL panels \approx 200 mm (8 in.) (California, 2004)

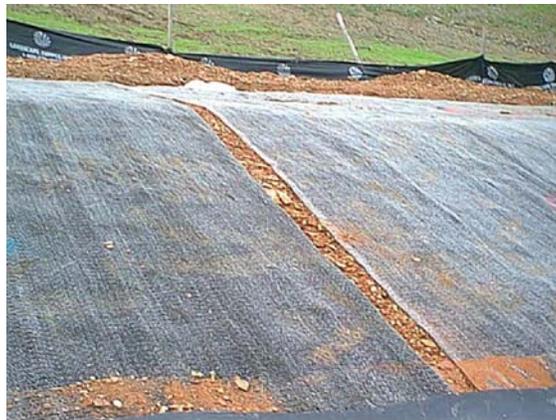
(c) Separation of GCL panels \approx 300 mm (12 in.) (Thiel and Richardson, 2005)

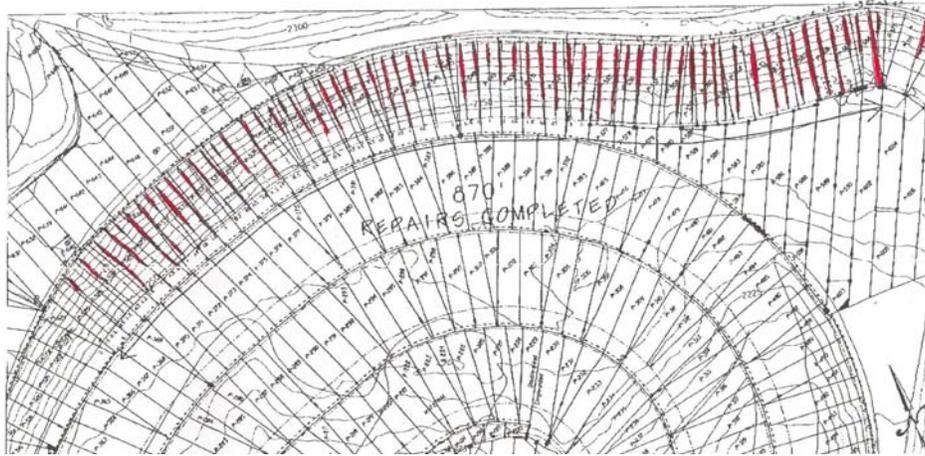
Figure 3 - GCL gaps at California landfill.

In 2004, GSI was called regarding the situation at a landfill in California. The geomembrane had been exposed for approximately three years and was being backfilled with a soil operations layer that contained some large stones. Damage to the geomembrane was observed and in repairing it, the underlying GCL was found to have separated. Further examination at other locations at this site found GCL panel separations ranging from 60 to 450 mm (2.5 to 18 in.), with a gap of 1200 mm (47 in.) in one location. As shown in Figure 3, essentially every adjacent GCL panel along the upper southerly facing bench of the landfill slope had gaps exposing the underlying soil subgrade. The site required 265 m (870 ft) of GCL and geomembrane repair using cap strips along with subsequent CQC and CQA procedures. Clearly, this case heightened the concern over in-situ GCL panel separation and prompted this White Paper.

1. Do not leave GM/GCL composite liners exposed to the atmosphere. Soil backfilling with at least 300 mm (12 in.) of soil in a timely manner (which is very much site-specific) should be adequate in this regard. [This engenders other issues, such as cover soil stability, but they are site-specific design concerns, see Koerner and Soong (1998)].

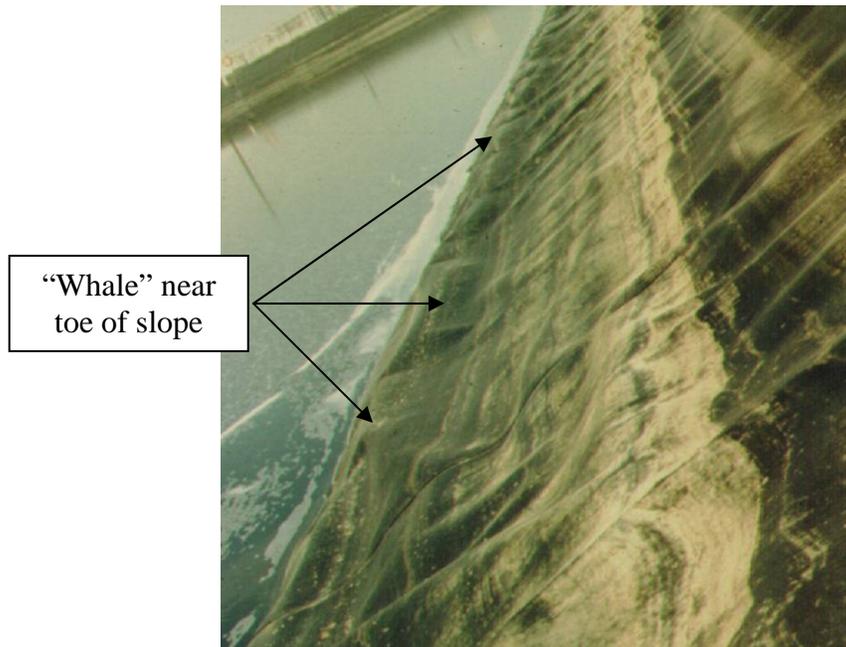
2. *Longitudinal Steep Slope Tensioning of the GCL* - Along with the daily expansion and contraction of the exposed geomembrane comes a gradually downslope moving wave which accumulates at the toe of the slope. This was observed at three of the cases in Table 1 and is regularly observed in exposed reservoir liners, see Figure 5.

Figure 5 - Horizontally oriented geomembrane wave in an exposed reservoir liner near the toe of slope. [This site did not have an underlying GCL and is only shown to illustrate the type of wave that exists in exposed geomembranes].

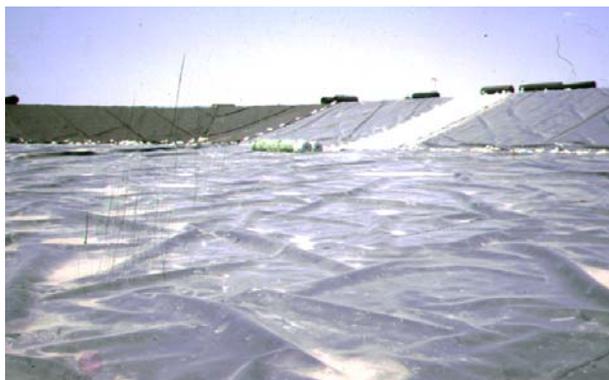
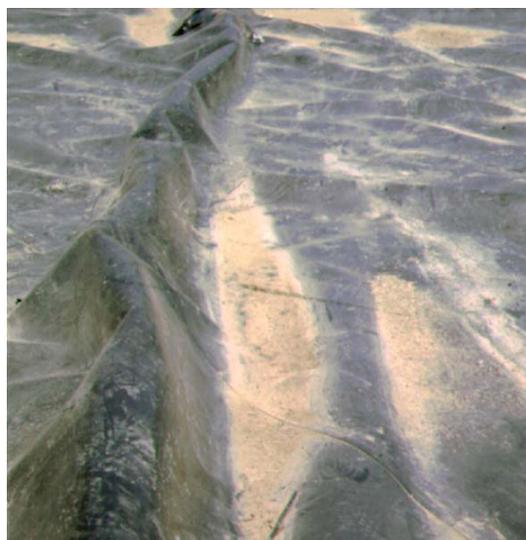
3. *GCL Contraction on Relatively Flat Surfaces*- Since all of the geomembranes were textured on their lower surfaces, an incremental so-called “hook-and-loop-effect” against the upper nonwoven geotextile of the GCL could occur in random orientations including transverse to the panel overlap. By cyclical expansion and contraction of the exposed geomembrane, the GCL may have been gathered beneath geomembrane waves (see Figure 9) during the warm part of the day and released during the cool night. This incremental gathering each 24-hour cycle may have caused the GCL to “bunch-up” within each panel losing a slight amount of overlap with each cycle. The cumulative effect could eventually cause some loss of overlap, which when combined with shrinkage, could cause GCL panel separation. While not felt to be the primary mechanism for GCL panel separation on steep slopes, it likely explains the one case (South America) where the GCL panels separated on a relatively flat surface.

Figure 8 - Waves in HDPE geomembrane on the relatively flat base of a landfill.
