PANEL SEPARATION OF GCLs UNDER AN EXPOSED MEMBRANE

GRI White Paper #5

In-Situ Separation of GCL Panels Beneath Exposed Geomembranes

April 15, 2005

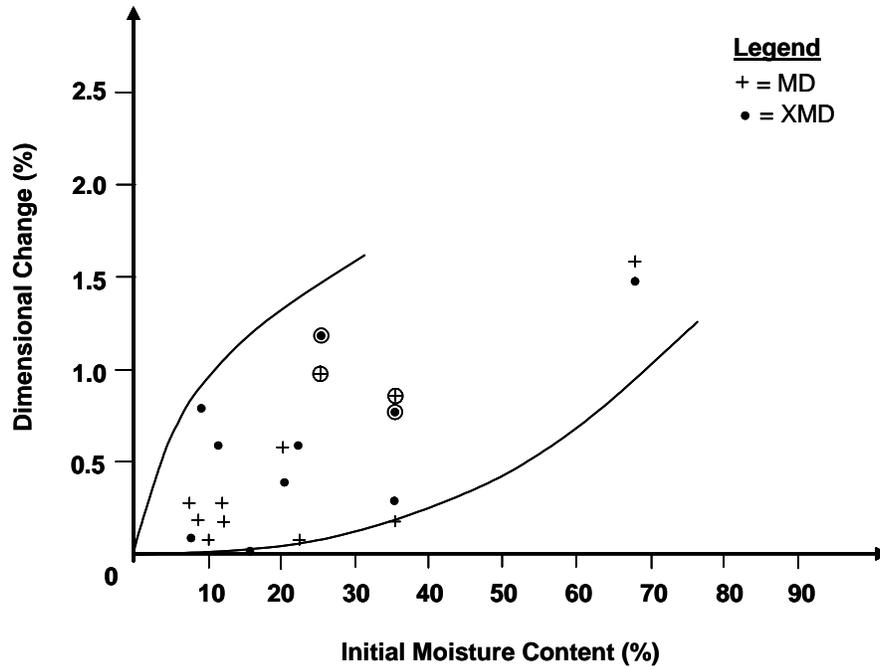
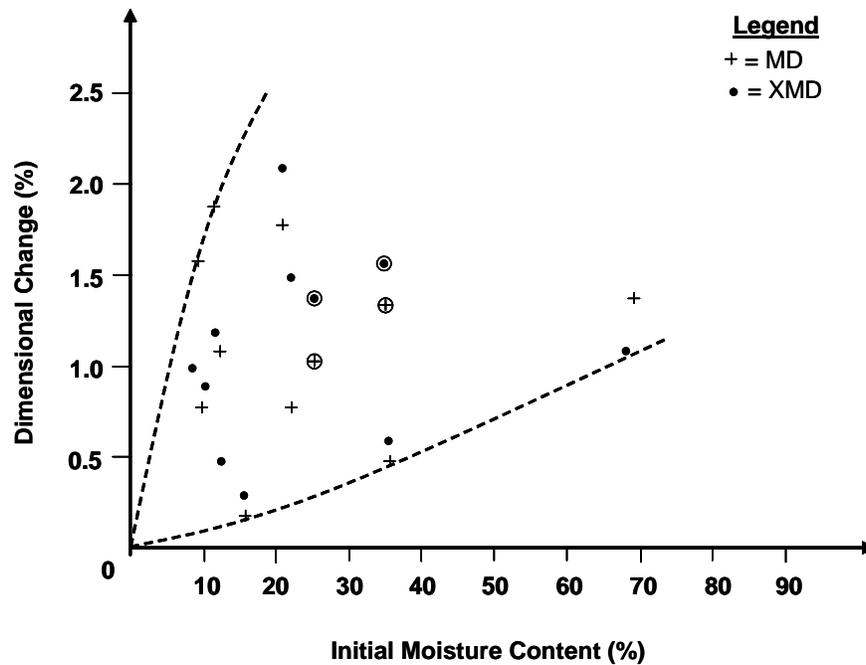
Laboratory test data by separate laboratories have been accumulated and are presented in Figure 4 where it is seen that the maximum length change (i.e., shrinkage) is 2.1%. Recognize, however, that at 110°C both the bentonite and the geotextiles may be involved in the process. At 60°C, however, the shrinkage is probably due to the bentonite alone. For a typical GCL roll width of 4.4 m (14.5 feet) this represents a maximum overlap loss of 93 mm (3.6 in.). Thus, a physical separation of the adjacent GCL panels to the point where the underlying soil subgrade is exposed would not occur

with an initial 150 mm (6.0 in.) overlap. Clearly, there is an additional mechanism(s) involved in these cases which is more serious than the GCL drying just described.

(a) Air drying at 60°C

(b) Oven drying at 110°C

Figure 4 - Dimensional shrinkage accompanying loss of as-manufactured GCL moisture content.

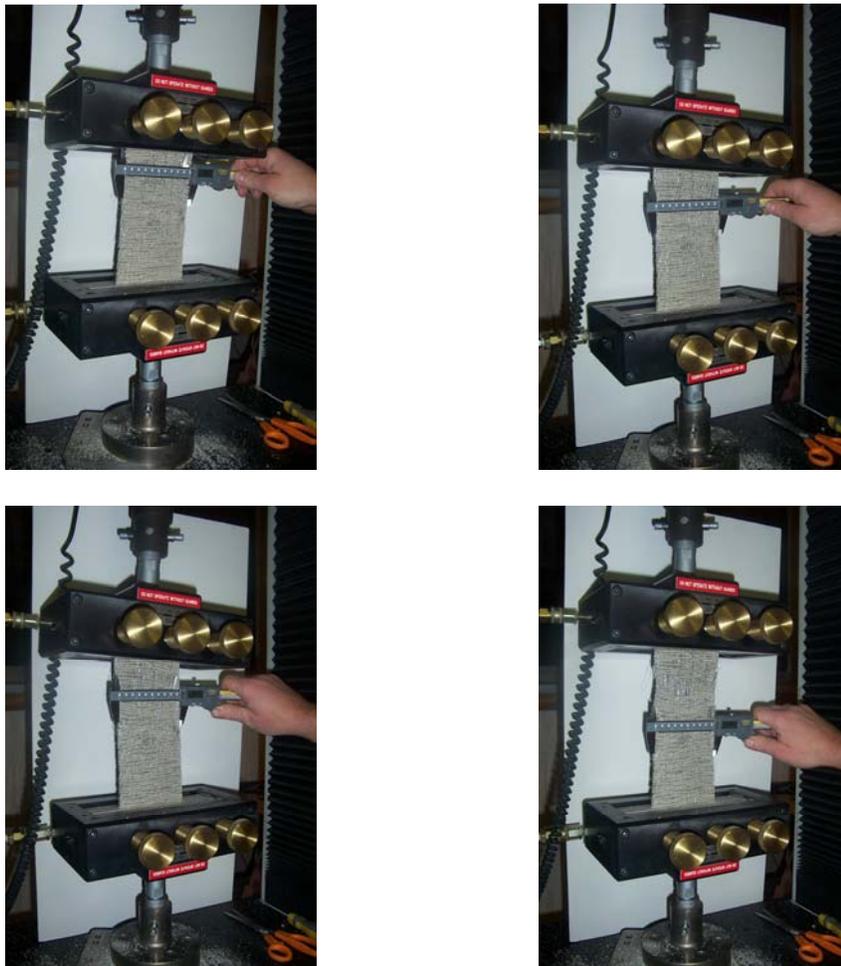
depreciated nonreinforced GCL with identical woven geotextiles [slit film in machine direction (MD) and yarn in cross machine direction (XMD)] on opposite sides of the bentonite. Figure 6(b) is a reinforced GCL with a needlepunched nonwoven geotextile on one side and a woven slit film geotextile on the other. Figure 6(c) is a reinforced GCL with needlepunched nonwoven geotextiles on both sides of the bentonite. The individual specimens are characterized by their aspect ratio which is defined as the initial length between tensioning grips versus the specimen width. Aspect ratios are typically from 2 to 10 for field deployed GCL panels depending on the slope length.

(a) Woven/Woven Nonreinforced GCL per ASTM D6768 (Massachusetts site in Table 1) [200 mm (L) × 100 mm (W); aspect ratio = 2.0]

Figure 6. Tensile tests on GCLs with accompanying measurements of transverse “necking”.

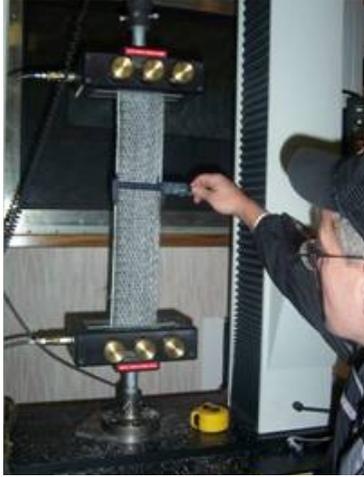
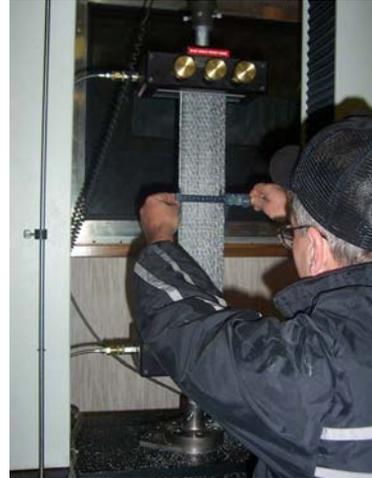
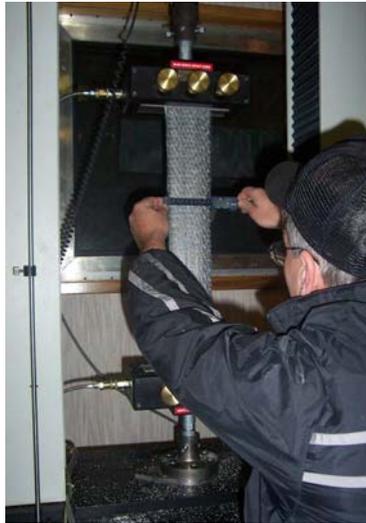
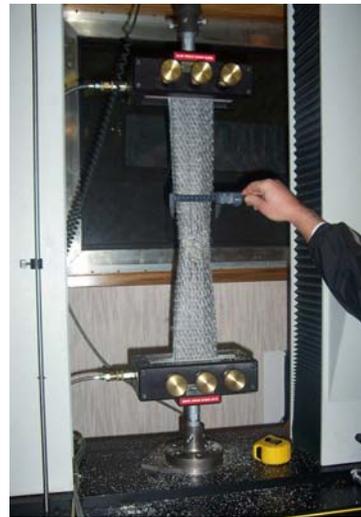
(b) Woven/Nonwoven Reinforced GCL per ASTM D6768 (Confidential site in Table 1)
[150 mm (L) × 100 mm (W); aspect ratio = 5.0]

Figure 6. Tensile tests on GCLs with accompanying measurements of transverse “necking”
(continued).

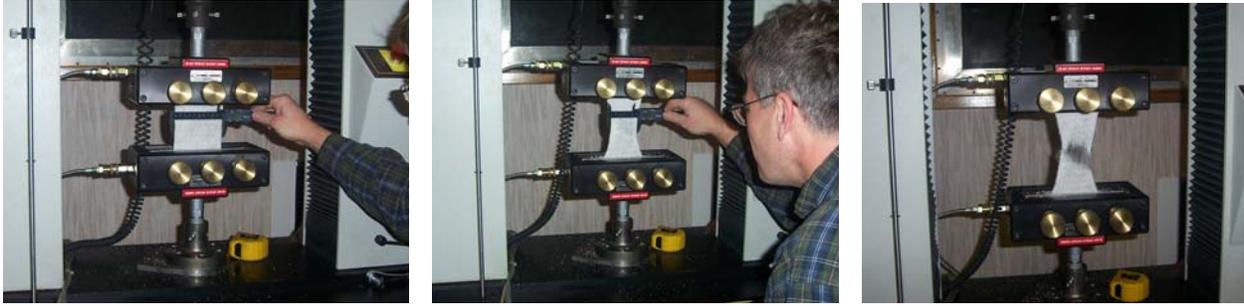
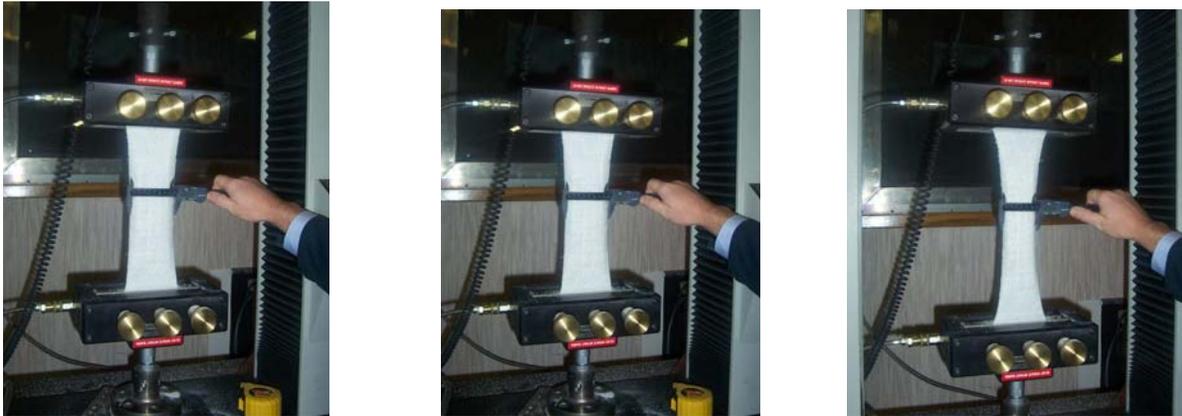
- [100 mm (L) × 100 mm (W); aspect ratio = 1.0]

- [300 mm (L) × 100 mm (W); aspect ratio = 3.0]

(c) Nonwoven /Nonwoven Reinforced GCL per ASTM D6768
(Virginia, South America, and California sites in Table 1)

Figure 6. Tensile tests on GCLs with accompanying measurements of transverse “necking” (continued).

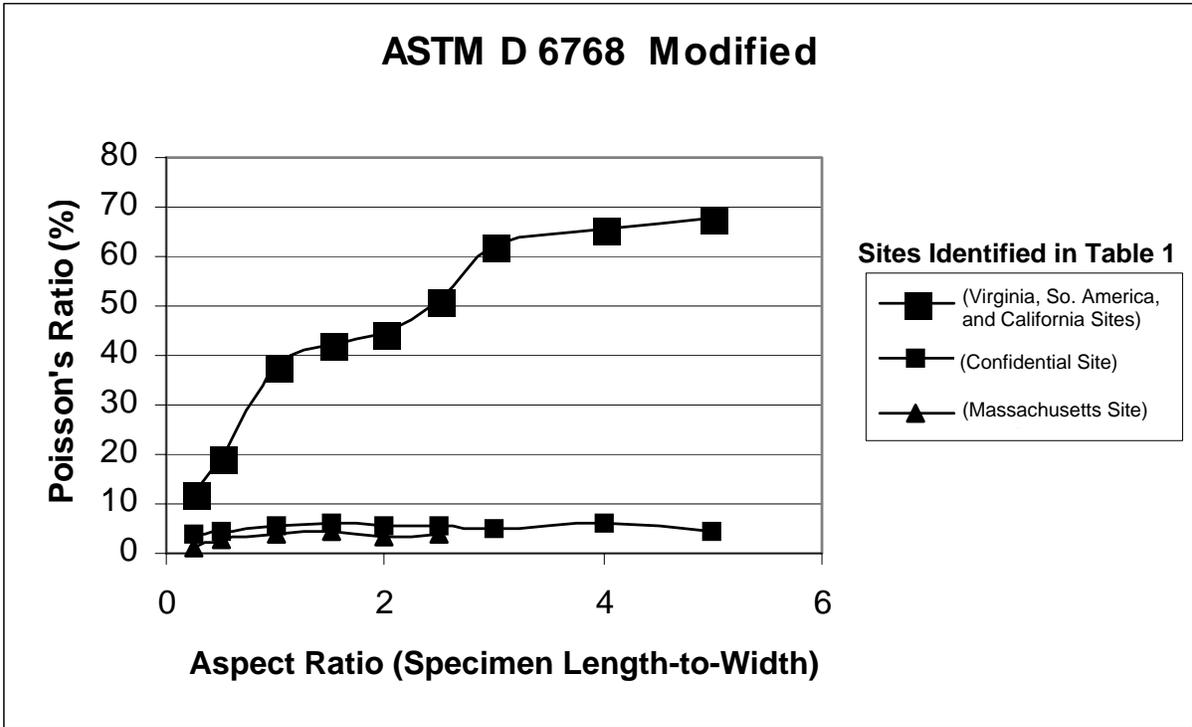
In conducting many such tests with specimens of different aspect ratios on the three types of GCLs involved in these cases and plotting the results against the resulting transverse “necking”, a Poisson’s Ratio graph of each GCL type can be generated. Figure 7 shows this response according to ASTM D6768 testing for various lengths of test specimens as defined by their aspect ratio.

Figure 7 - Results of tensile tests with measurement of transverse “necking”, aka Poisson’s Ratio, versus Aspect Ratio of original specimen length-to-width measurement.

This important set of curves readily provides the necessary information and explanation into why the panel separation distances described in Table 1 are so large; particularly the California site which experienced, by far, the greatest panel separation distances. Table 2 gives the requisite calculations based upon a GCL panel width of 4.4 m (14.5 ft). While the data speaks for itself, one can easily substantiate the magnitude of GCL panel separation distances in all of the cases (including the California site) under investigation.
